**PEQUONNOCK RIVER BASIN  
BRIDGEPORT, CONNECTICUT**

**FOREST LAKE DAM  
CT 00078**

**PHASE I INSPECTION REPORT  
NATIONAL DAM INSPECTION PROGRAM**

**AUGUST 1978**

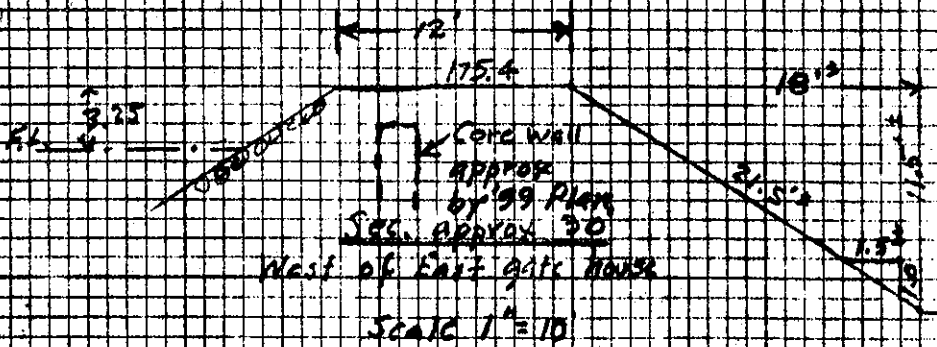
NOTE: Top of dam and slope covered with trees and undergrowth.

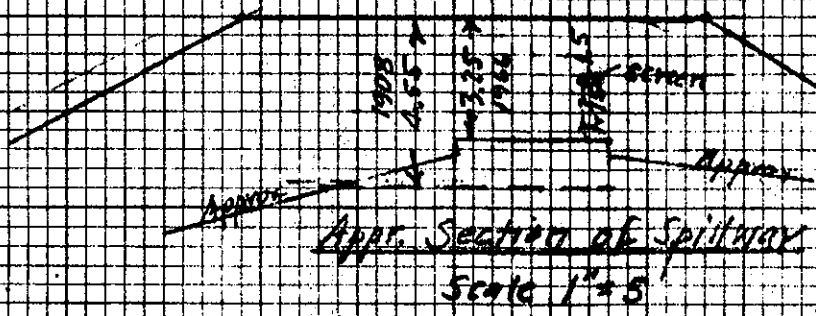
NOTE: Evident spillway is inadequate; that screen should be removed, and that other measures should be taken to provide required safety.
